Debris Control Structures – What they are and why we need them.

By Murray Powell – Optimal Stormwater, and

Peter Garland - Wollongong City Council

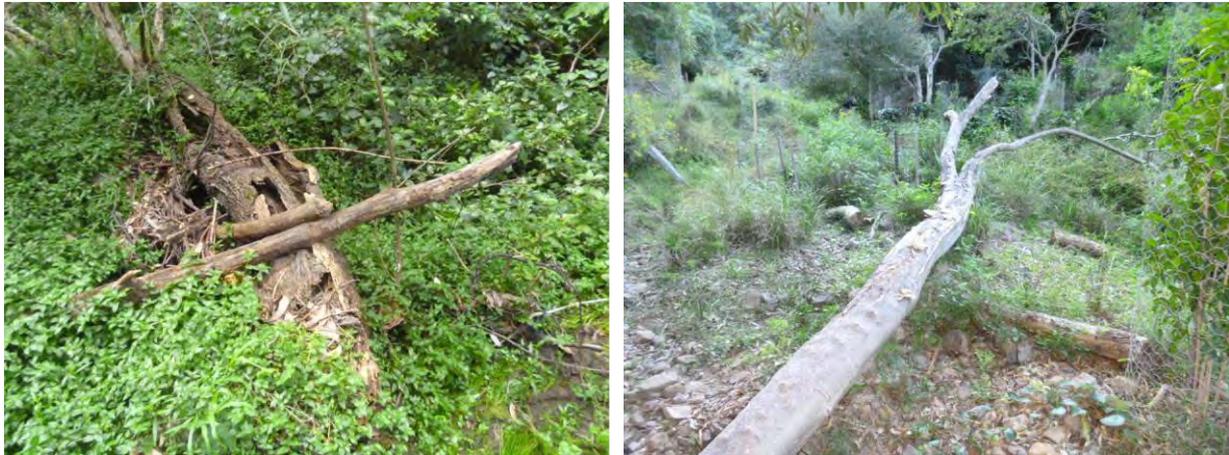
One of the most common aspects visible at all of the sites visited was the level of potential debris present. Most of the sites were downstream of areas with steep catchments and medium dense vegetated banks. These banks commonly had dead or weak trees with overhanging branches

extending into the channel. During larger velocity flood events these overhanging branches or the whole tree itself could end up coming down the line, potentially blocking the inlet structures and causing flooding upstream. A majority of the sites also had evidence of fallen branches and uprooted trees from previous floods which had not been carried all the way to the inlets yet.

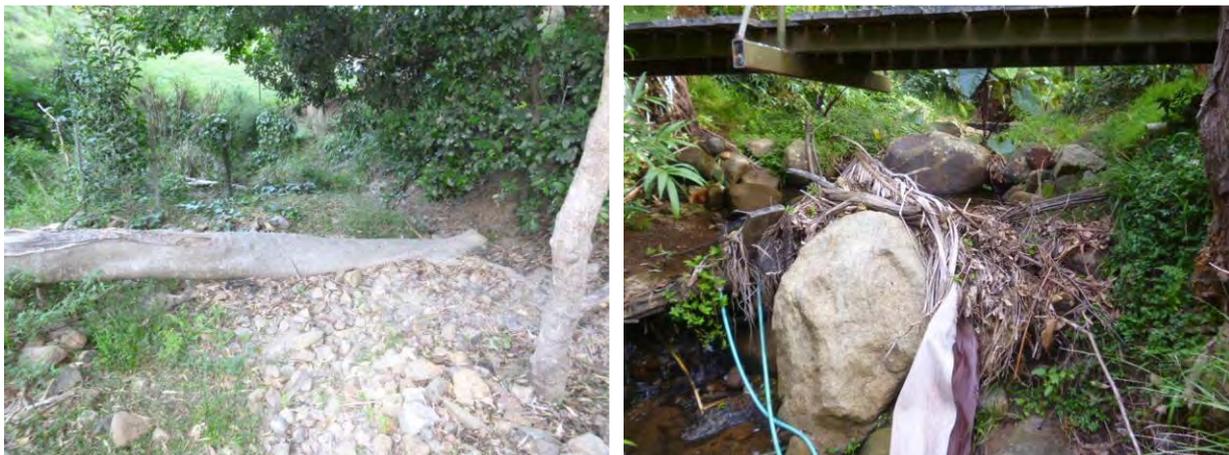
Another potential issue is large rocks and boulders. Given that the catchment upstream of most of the inlets is very steep and beginning at the peak of the Illawarra Escarpment, velocities can get very fast moving and this presents a powerful erosive force. This creates the potential for the flows to transport very large and/or heavy items found in the upper reaches of the catchment. Although there was no evidence of it during the site visits undertaken, Council advised that there had previously been vehicles carried during the flood events. There was, however, evidence of illegal dumping at several locations. Although the items were small in the majority of cases, there was evidence of larger items, in one location a couch and shopping trolley had been dumped that would easily have blocked under the next bridge downstream.

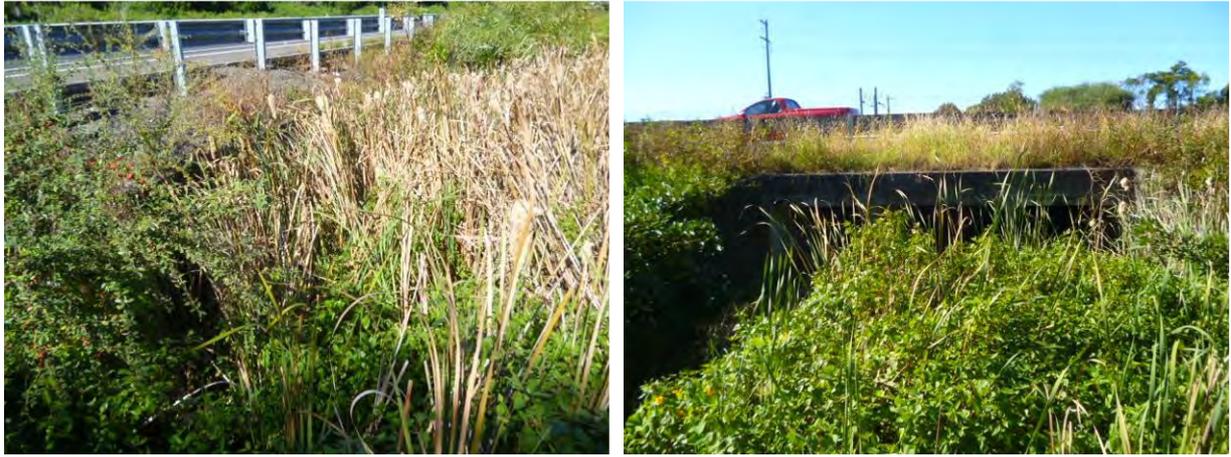
It was also observed that the majority of the sites had large levels of organic growth around the inlet structures or not too far upstream. This vegetation causes another potential catch point for the debris, but also encourages deposition of sediment. This sediment builds up over time, more vegetation grows through the sediment, and this cycle causes channel constriction and potentially blockage of the inlet structures.

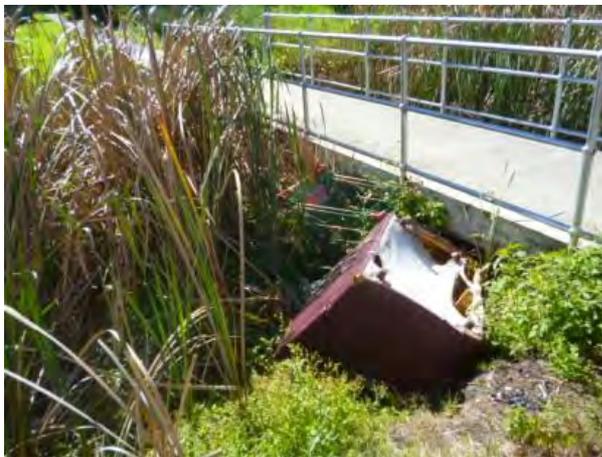
There is a pedestrian bridge which is located approximately 12 metres upstream of the culverts. The pedestrian bridge has a deck span of 8m which would allow free flow, and is not seen to be a constriction. At the time of the site visit, a depth to underside of the pedestrian bridge was not measurable as there was a significant build-up of sediments, debris and vegetation. But these can be reasonably easily removed.

Figure 1 - Upstream pedestrian bridge with sedimentation, vegetation and illegal dumping.

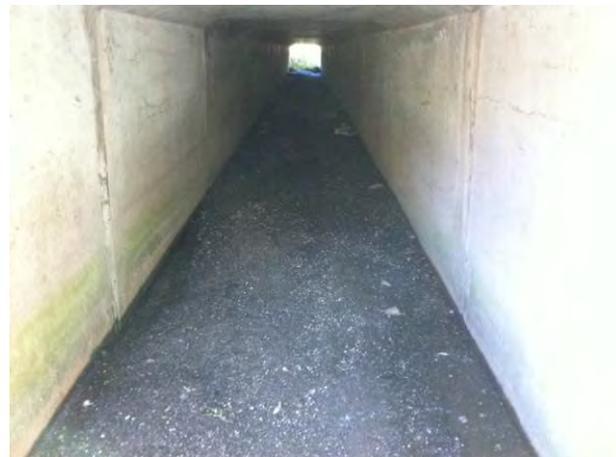
Figure 2 - Downstream culvert, under a major RTA road.

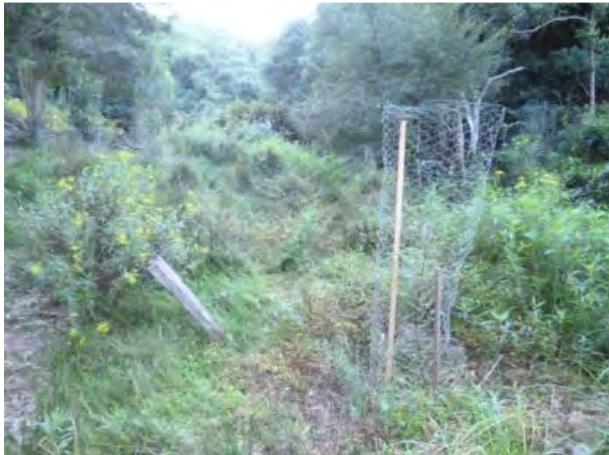
Figure 4 - Upstream the valley/creek area contains rolls of fencing wire and plenty of large dead trees.

There is also evidence of planting new trees in the upstream reaches of the flow path. This has the potential to cause issues as these trees are susceptible to uprooting and can cause blockages. Given the steepness of the upstream catchment, there is a large potential for these young newly planted trees to be uprooted and carried. There is evidence of large trees and boulders which have been moved by previous flows. It is proposed to remove the wire from around the newly planted trees and remove any older weaker or dead trees which will cause blockages.

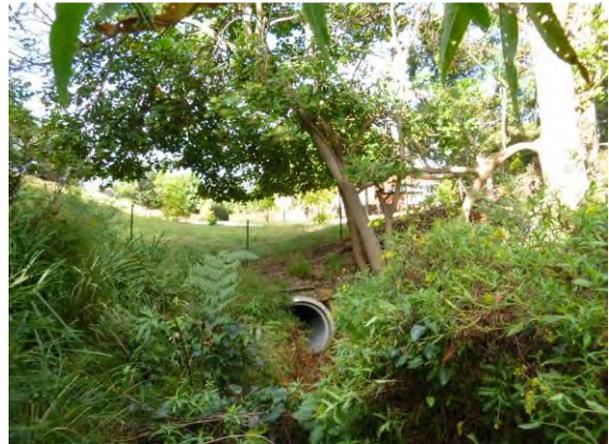
Figure 5 - Downstream the inlet structure

The site currently acts as a detention basin with the boundary to the neighbouring property acting as a headwall of sorts. Given the potential extreme velocities and the depth of the outlet pipe in relation to the neighbouring properties, it is proposed to further formalise this 'basin' effect. It is proposed to extend the existing 1050mm pipe upstream approximately 2m (to create an area for access to maintain) and then create a 6m wide x 6m long x 2m deep area upstream of the extended pipe. It is then proposed to install Reno mattresses and gabion walls (or similar) along the ground and walls respectively. This will give structural support to the walls and ground. It is proposed to install bollards at 0.7m centres along the upstream face of the gabion wall across the channel. This will capture large debris which would otherwise gather at the face of the inlet structure. The bollards have been spaced at 0.7m intervals to capture debris which is larger than the width of the pipe, but will allow smaller particles to pass through both the bollards and pipe.

Relocation of the inlet structure will allow for a maintenance access to be constructed as well as giving room to raise the headwall above the inlet pipe, effectively creating not just control of large debris, but also creation of a formal detention basin.

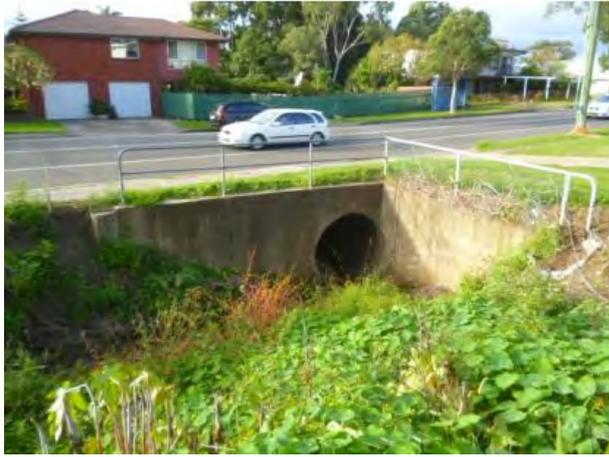
This particular site has multiple issues: existing ongoing erosion, illegal dumping, high inlet blockage potential because of its configuration, it's very close to the road and neighbour, there are high risk services exposed just upstream.

Figure 7 – Inlet structure

Given the abovementioned issues for this site, a redesign of the existing area is proposed. It is proposed to extend the existing inlet structure approximately 20m upstream, past the exposed and undermined service pipelines so these can be backfilled over, and protected.

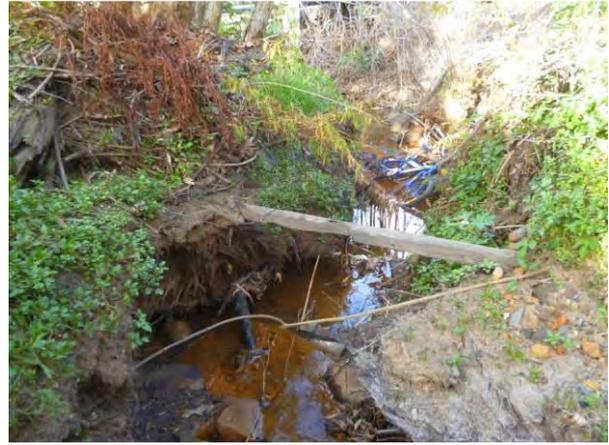
The area immediately upstream of the site is relatively flat and the overland flow path is relatively wide, meaning the velocities are lowest at this point, however there is still evidence of scour along the creek line and its surrounds. There is a potential for illegal dumping in the area, and as such it is proposed to install concrete filled bollards to prevent potential destruction of the debris control structure.

Figure 8 – Evidence of scour and debris within channel
