Auditing and Maintenance Costing of Gross Pollutant Traps

Protecting our Urban Waterways - Water Quality and Managing Flow Impacts

Abstract

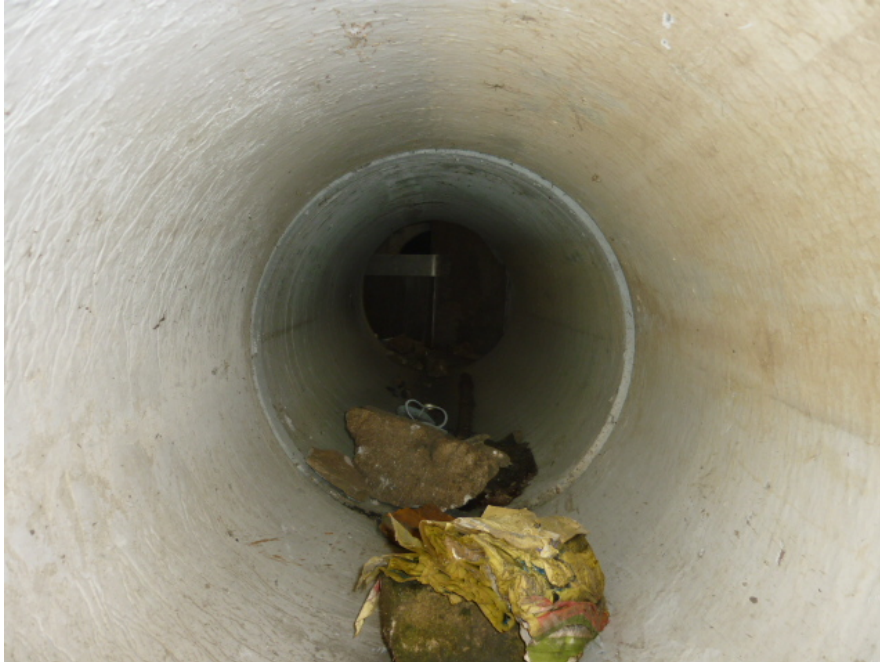
Rocks in pipes

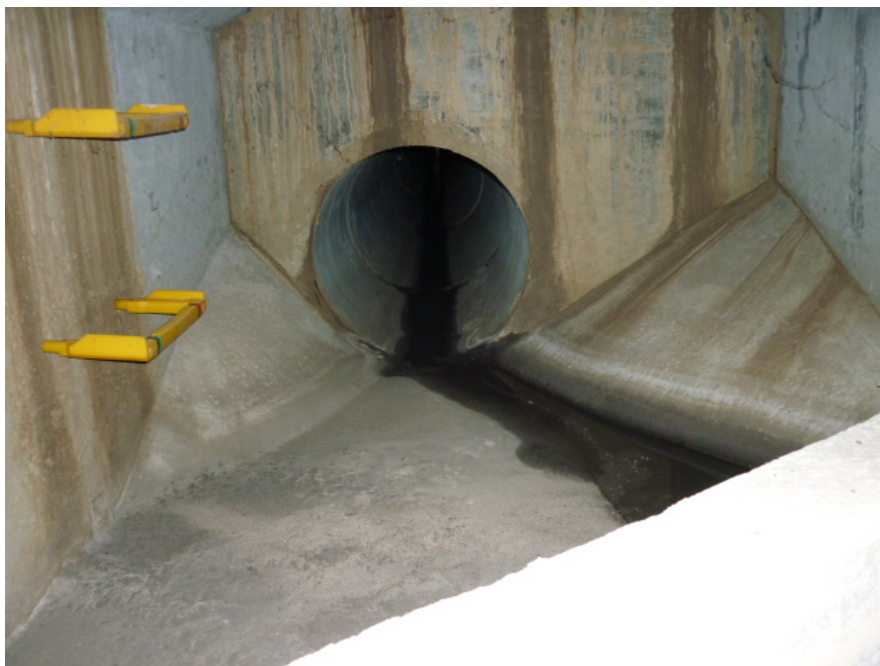
A correctly installed and well maintained diversion chamber

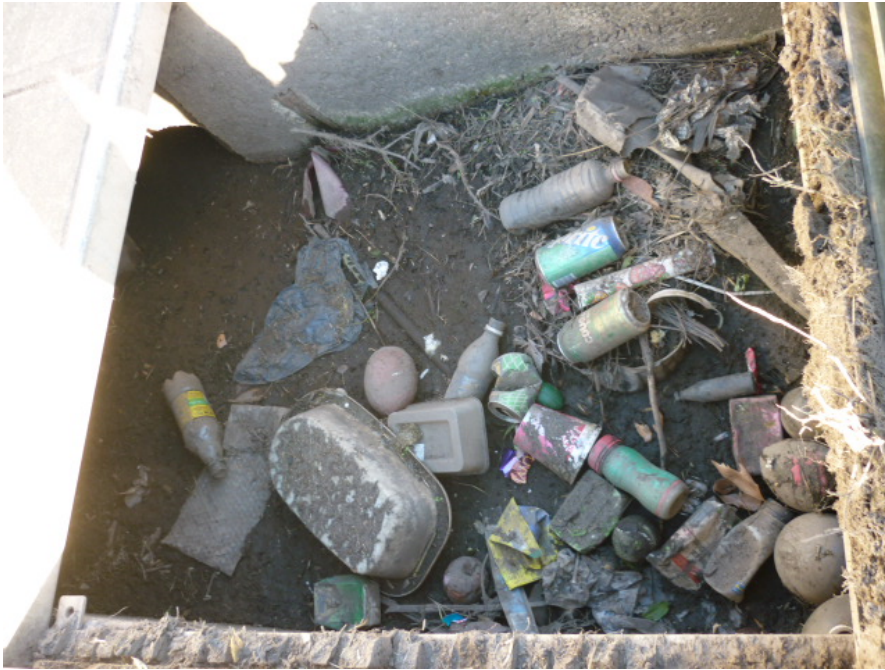
Pits were found that required cleaning that were not included on Council's maintenance list

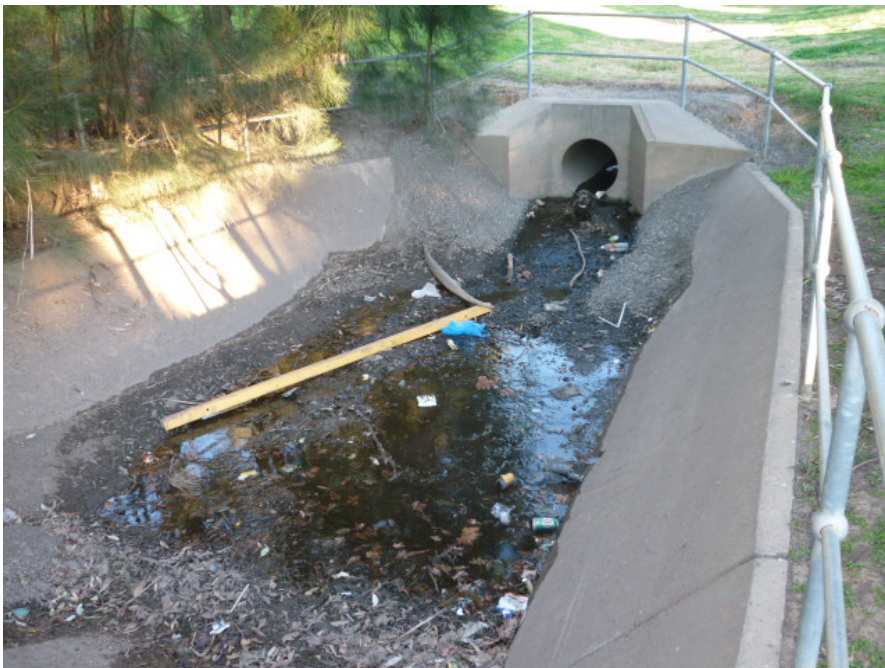
Older style GPTs, can often be upgraded and their performance enhanced

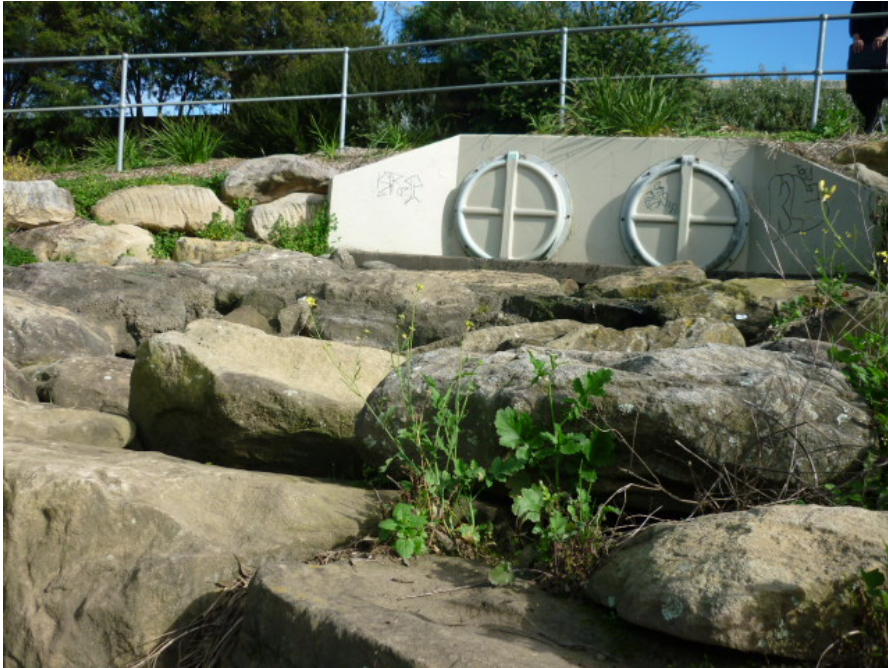
The hydraulics of the Humegards upstream is compromised by the addition of “tidal flaps” that are probably not necessary in this location

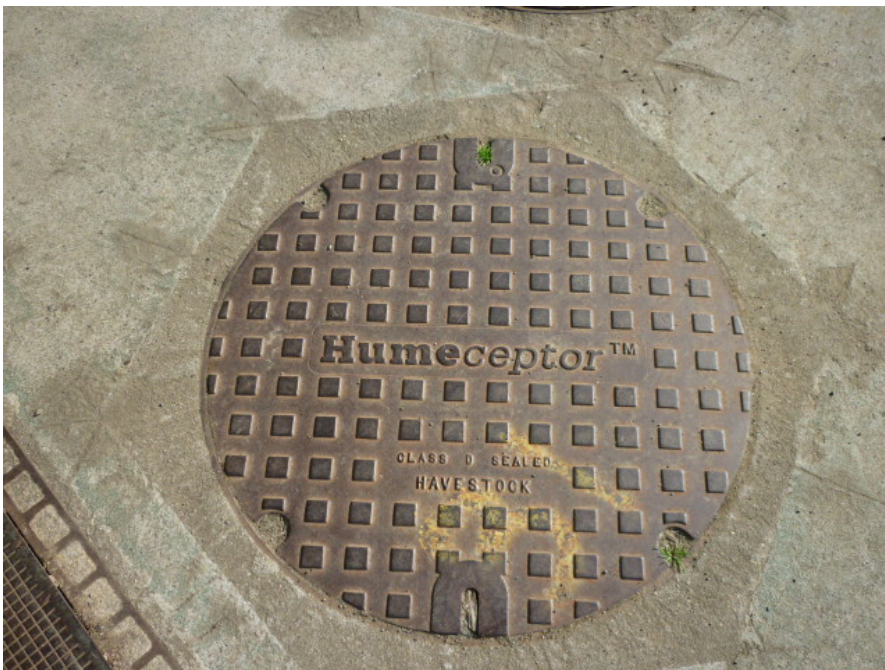
The lid to this GPT says Humeceptor, however it's actually a Humegard. Incorrect product identification (or no product identification) can be a problem

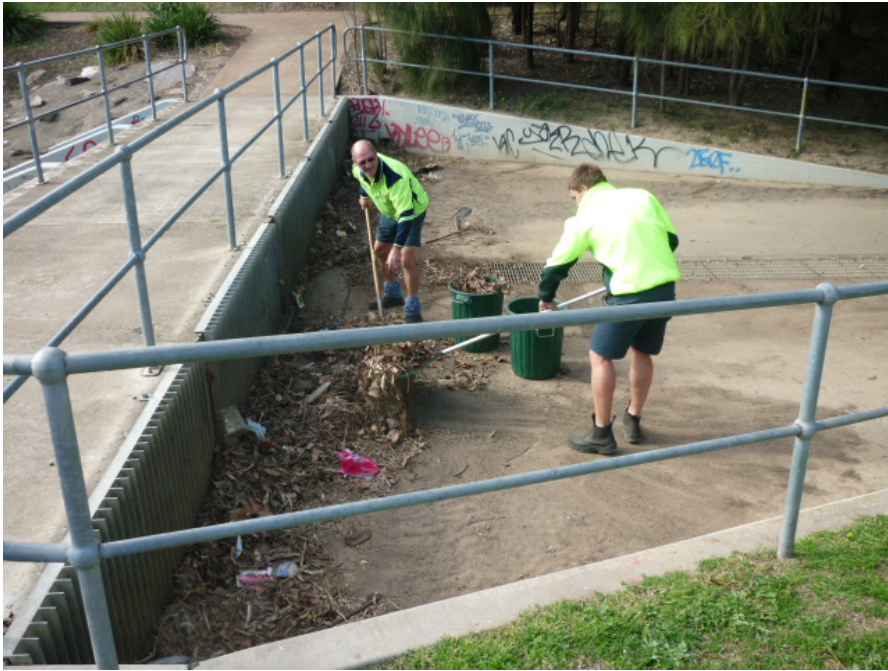
In most locations, other solutions that are more sympathetic to the aesthetic values of the surroundings may be more appropriate

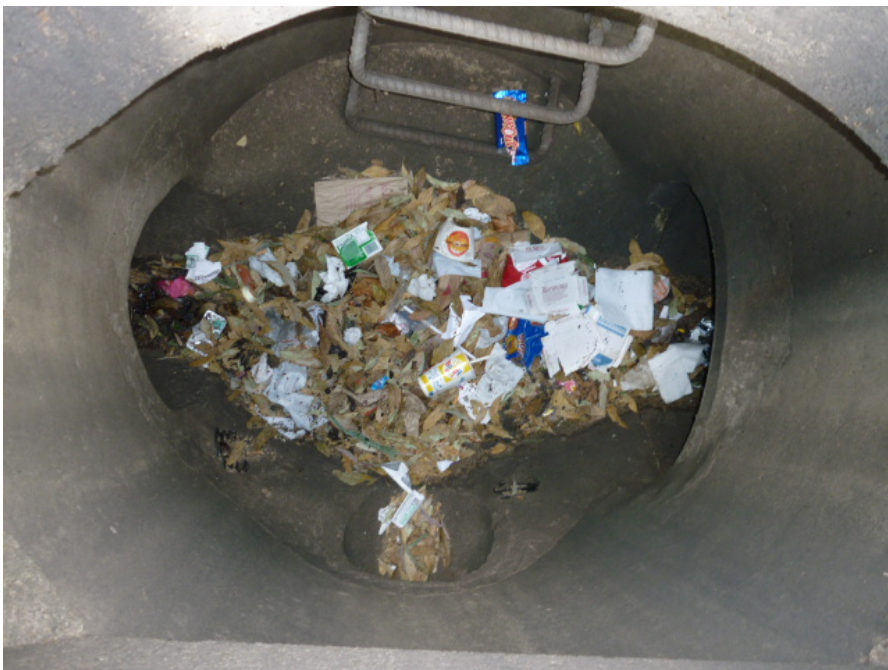
Litter in a gully pit, at a busy shopping centre showing evidence for the need of protection by pit traps, or a GPT

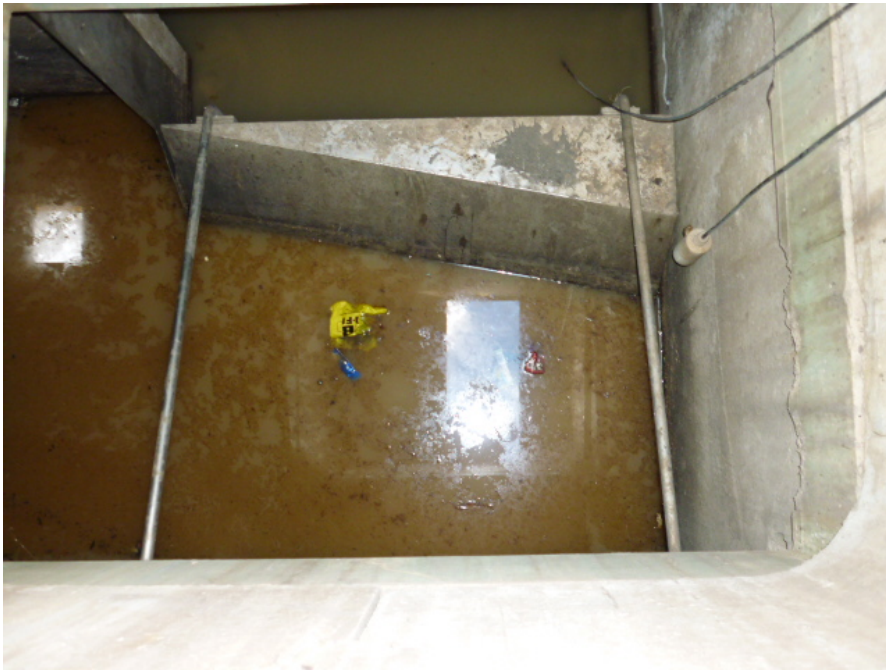
Backwater in this Humegard complicates the cleaning process, because it must be suction cleaned

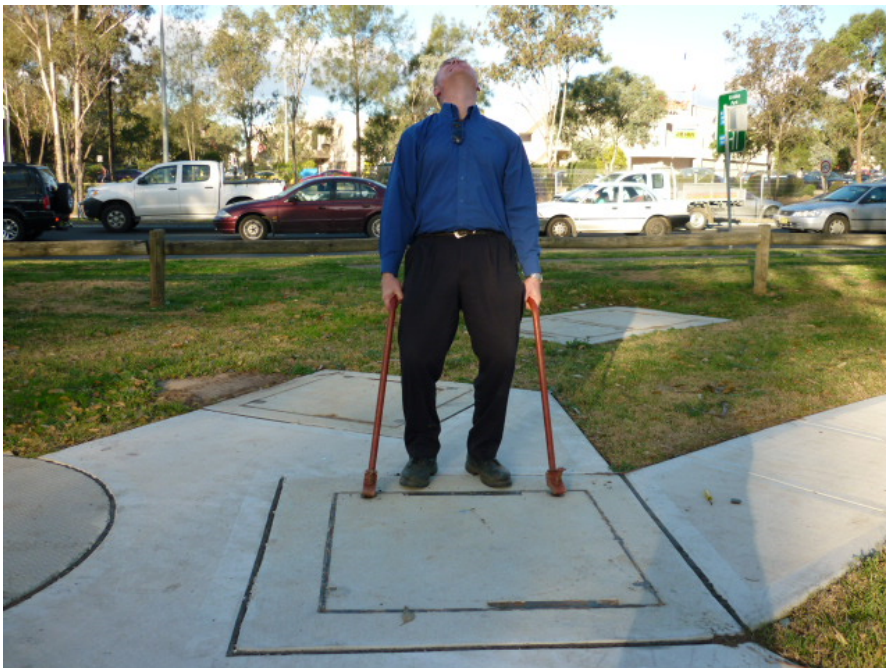
Some lids can be so heavy that they do not comply with workcover requirements to open them, or like this one, cannot be opened at all.

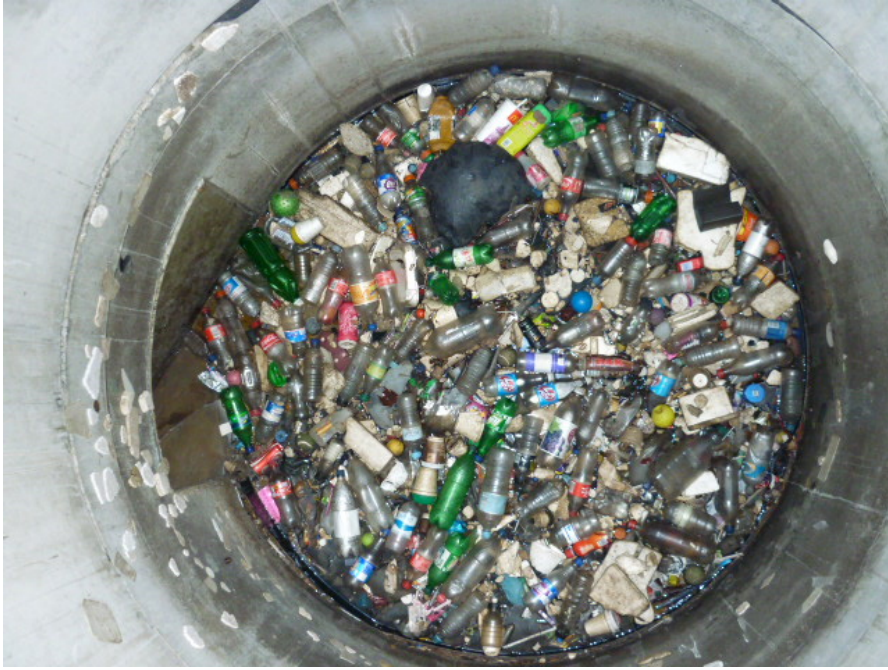
The surface of this CDS unit was covered in floatable pollution and assessed as 100% full with approximately 10 tonnes contained in the sump, it is working well and ready for a clean

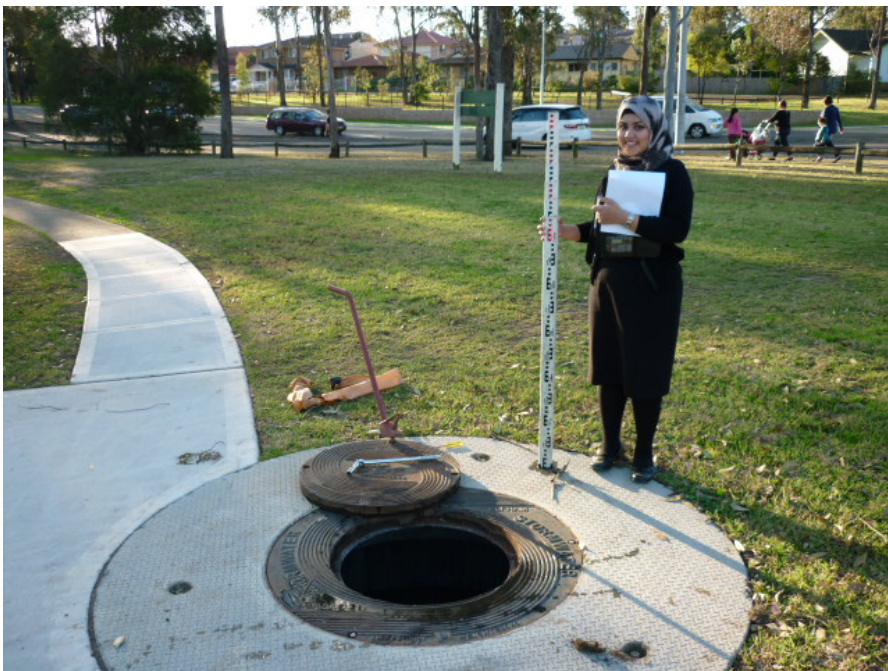
It's important to have the correct tools to access and monitor the GPTs, these include a Data Sheet for the GPT, a staff, gatic lifters, sockets, screwdrivers, allen keys, etc

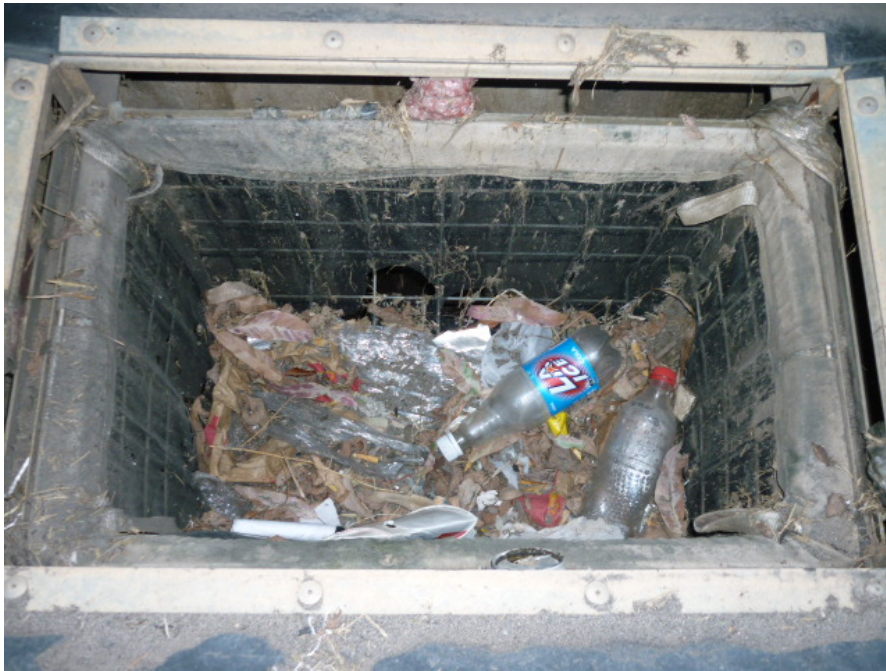
The mesh in this Enviropod Pit Trap is too fine. The mesh is also torn and there is pollution stuck on the overflow supports suggesting pollution is bypassing. Use of coarser mesh is suggested, plus more regular inspection and cleaning

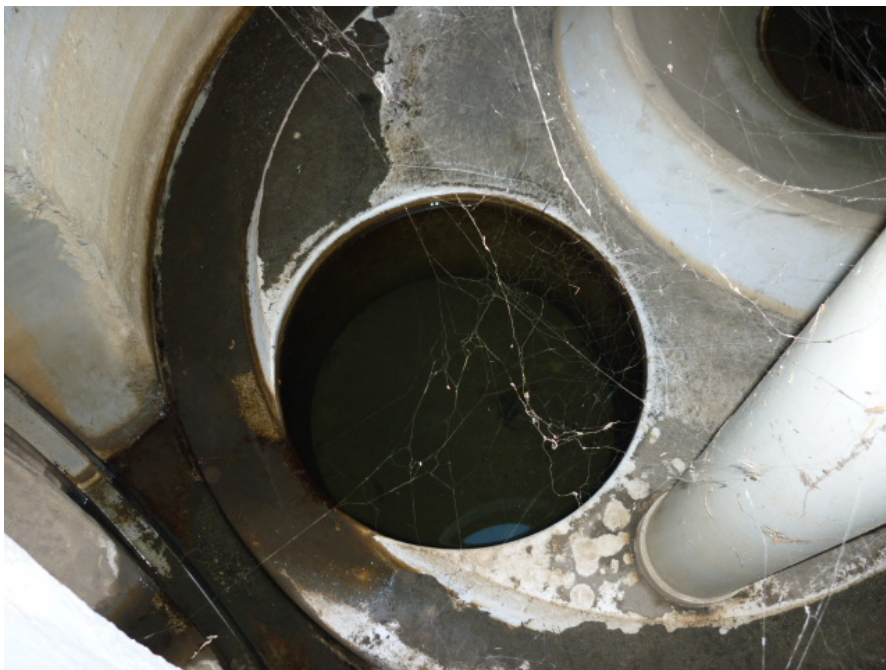
This Humeceptor has considerable sediment deposition on the fibreglass insert, and requires a thorough clean

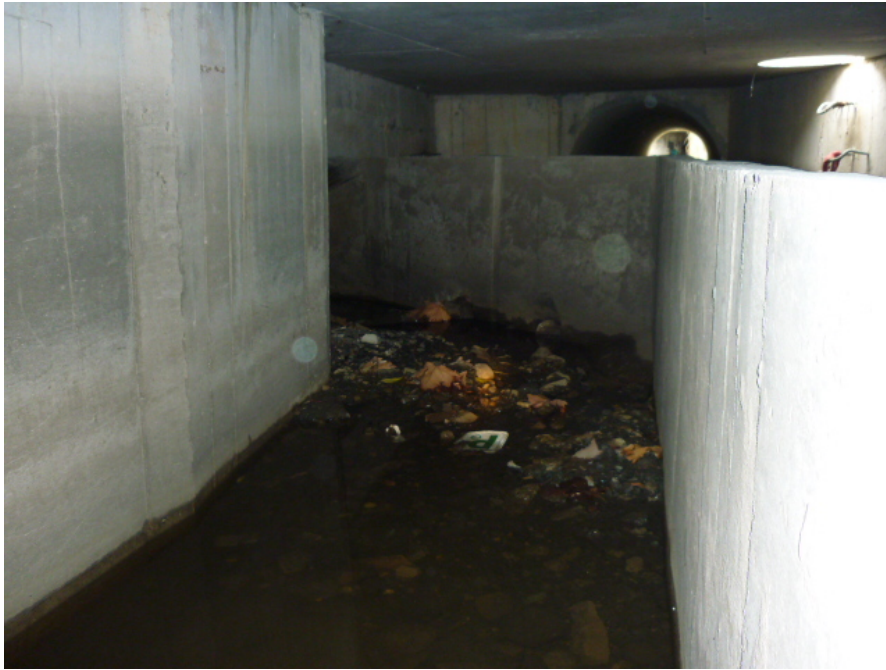
Coarse sediment deposited in diversion chambers, can cause water to pool back up the pipes. Inspection and cleaning of chambers should be included as part of the cleaning requirements for all CDS Units and other GPTs as well

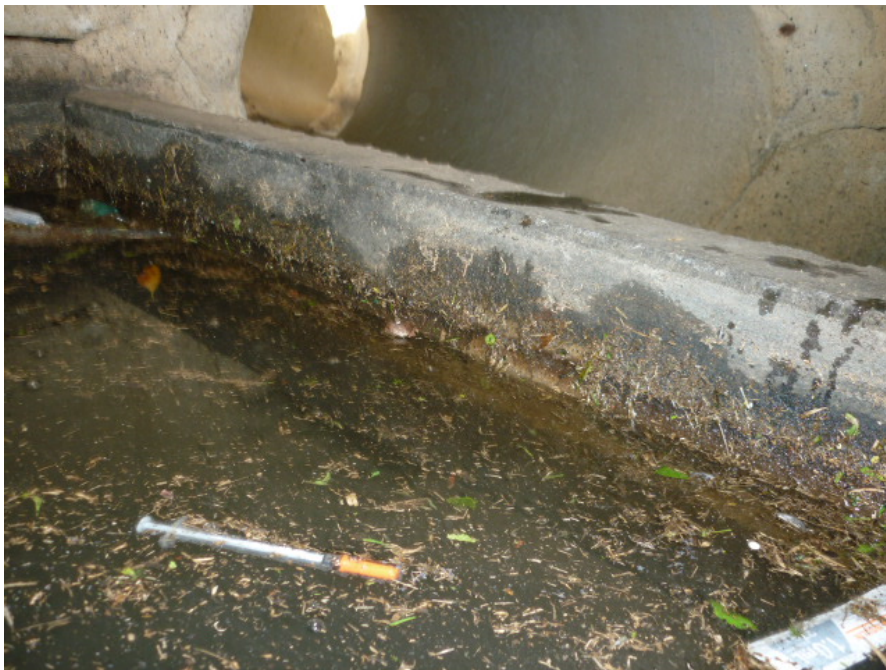
This Downstream Defender has a submerged offtake or a blocked offtake and as such, the syringe shown here is likely to bypass the weir and as such modifications to this GPT are required.

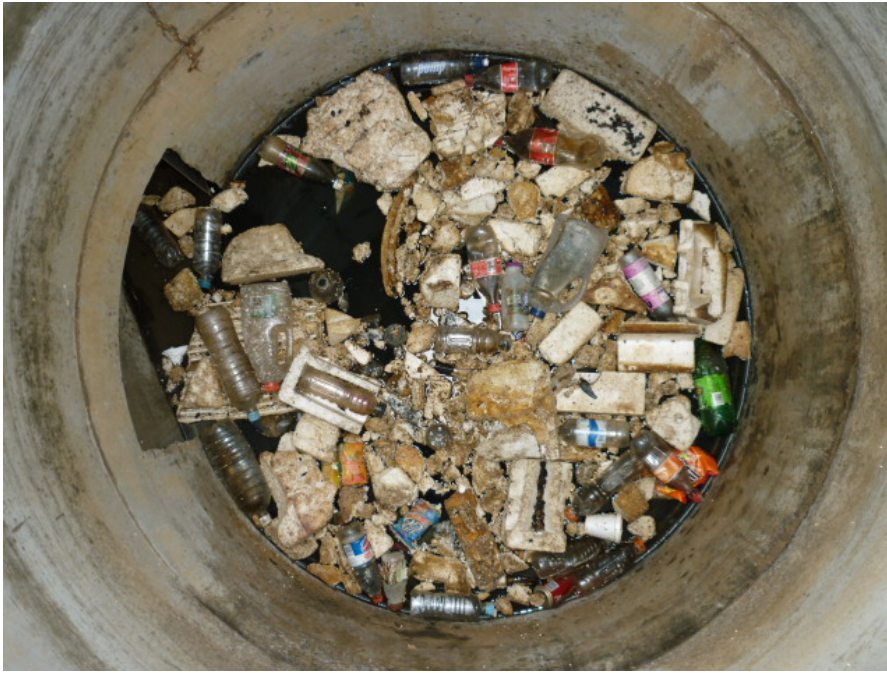
Polystyrene from building sites and urban development is very common and this GPT is working well to capture them

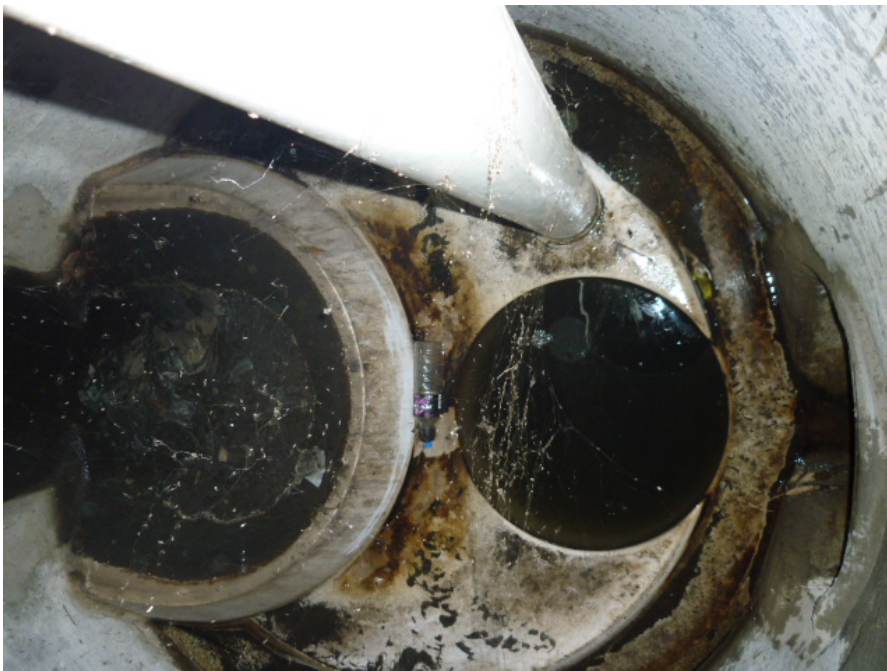
The inlet on this Humeceptor is blocked and requires cleaning to reinstate the device to operational

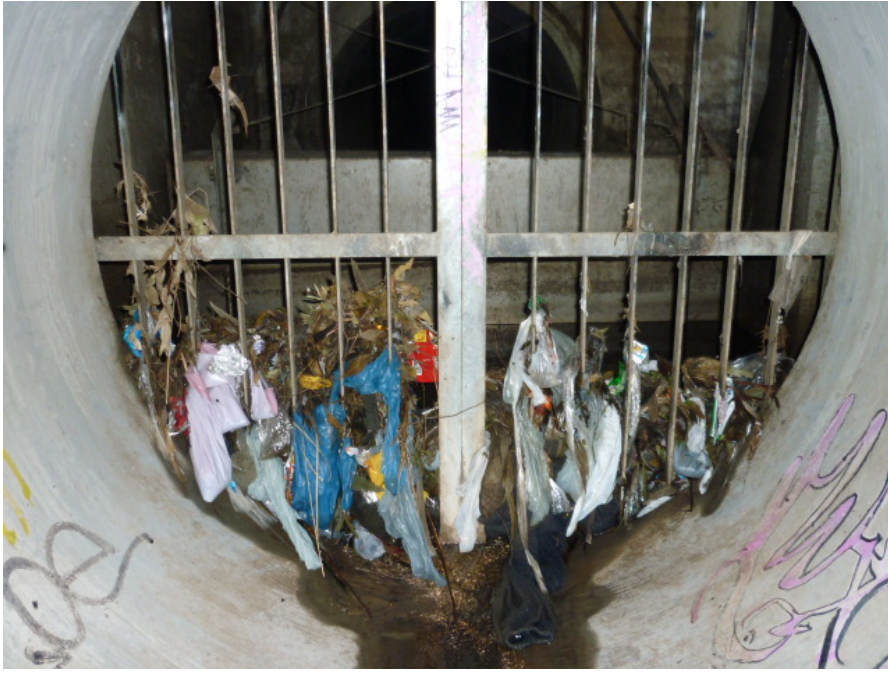
Exclusion bars can be necessary to keep kids out of some GPTs, but they can also present potential problems for hydraulics, performance and maintenance, if not designed well or poorly located.

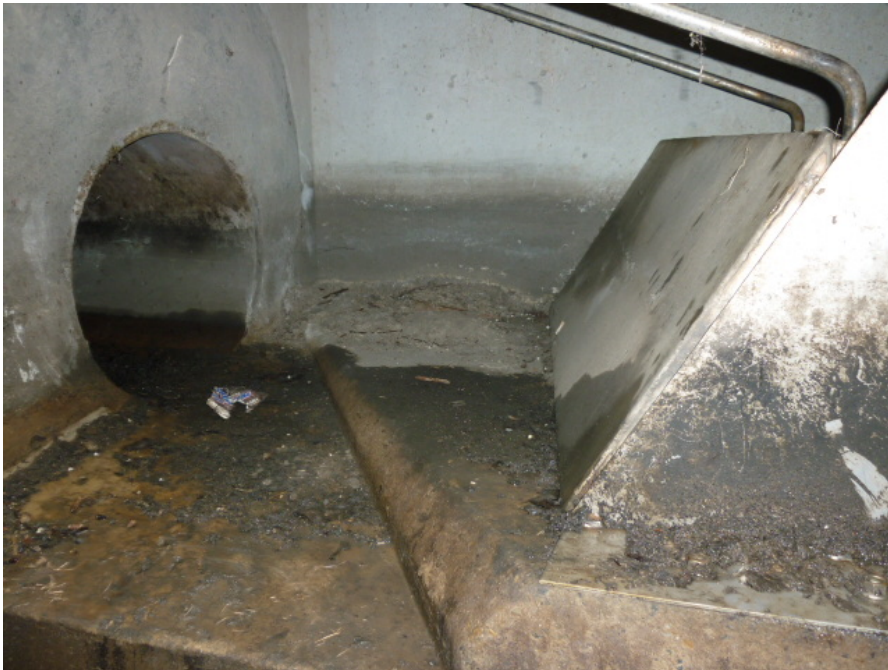
The scum on the Humegard boom and "tide line" back up the pipe, indicates this Humegard blocks regularly, so monitoring and maintenance should be increased.

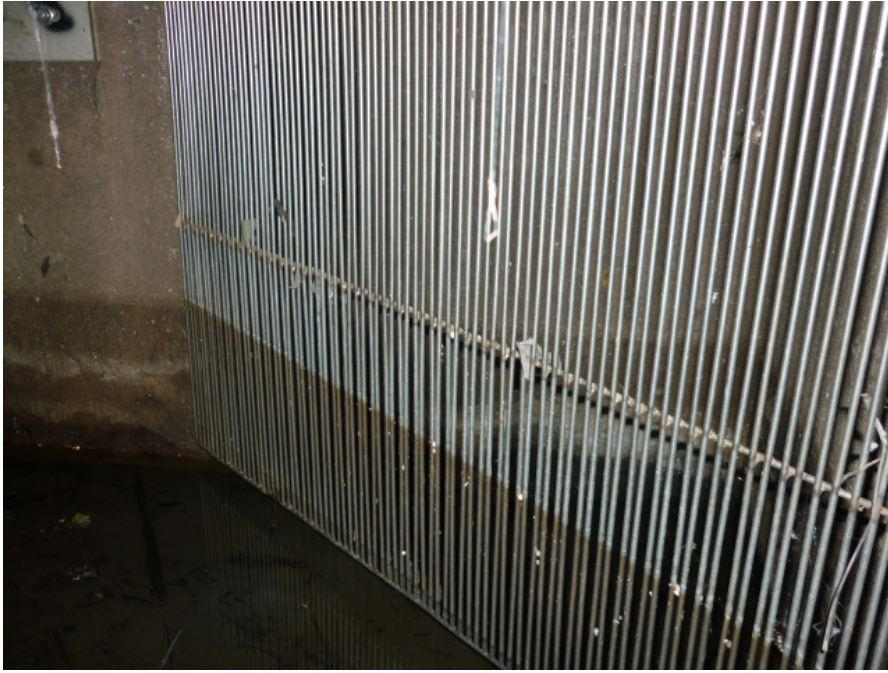
A Humegard screen cleaned and ready for action.

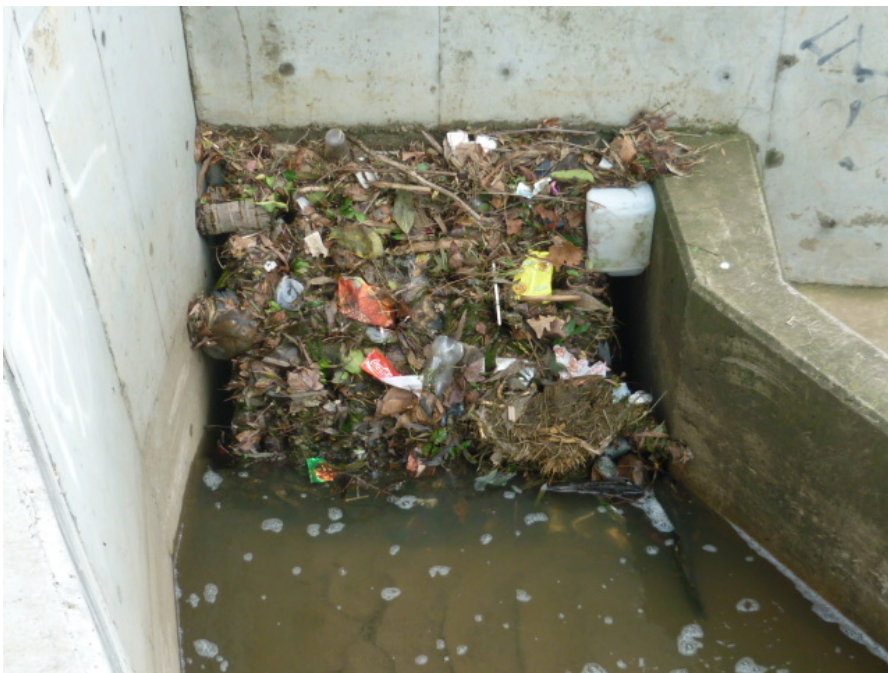
The design of the offtake into this undersized GPT is very poor. This photo was taken one week after cleaning. Exclusion bar design can limit GPT functionality if not done well, and be a maintenance nightmare

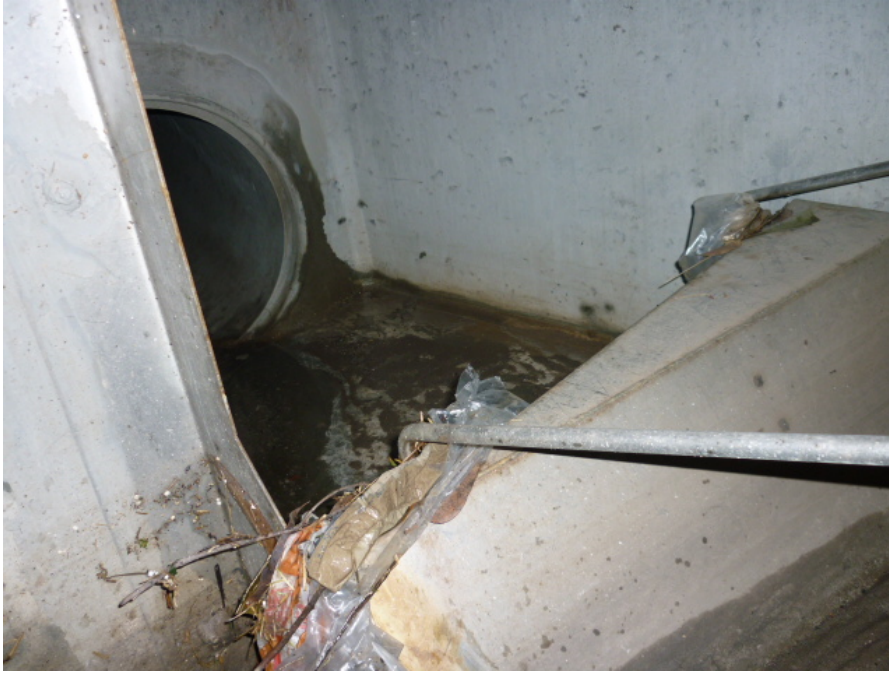
The Humegard boom is not supposed to overtop, but the plastics caught above show that obviously it did. The boom may be stuck or somehow impeded and requires cleaning and investigation

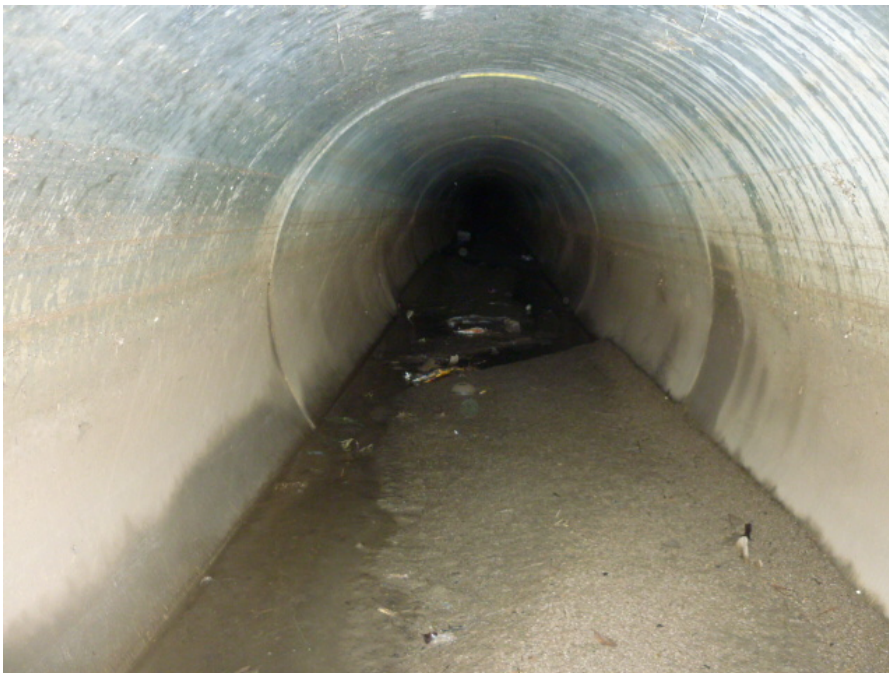
Massive sediment deposition in all the upstream pipes has resulted when developers failed to clean the GPT downstream

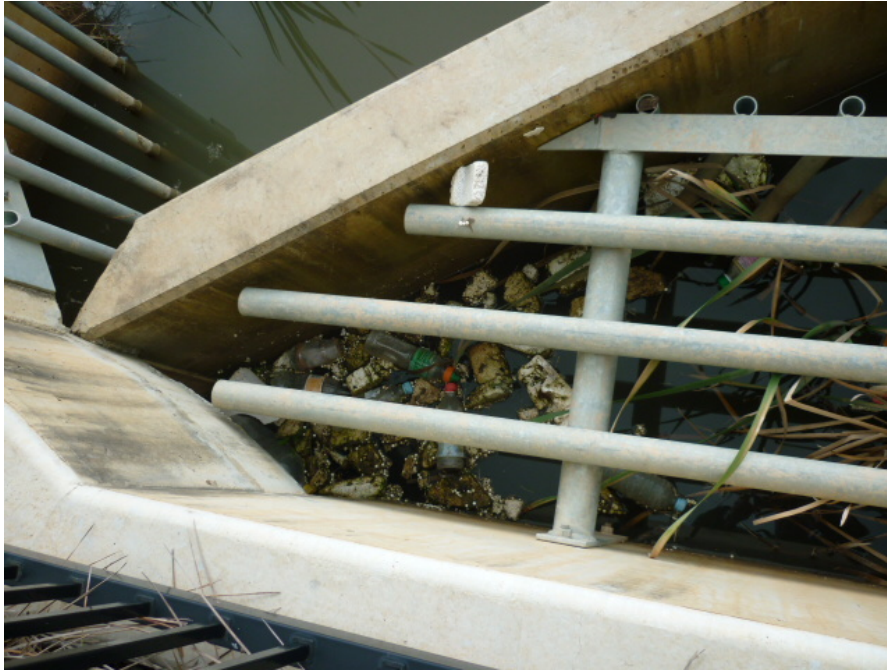
Backwater from downstream has affected the performance and ease of cleaning of this CDS unit. Floatables and macrophytes in the inlet can be seen. Cleaning and downstream works required.
